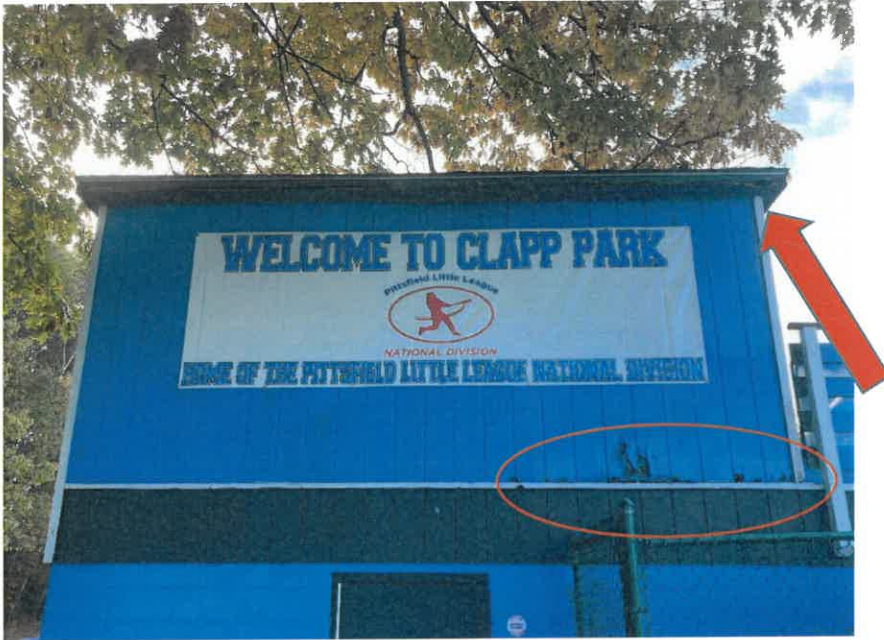
The Little League building at Clapp Park. Note the deteriorating fascia boards at the roof line and the weathered exterior siding.

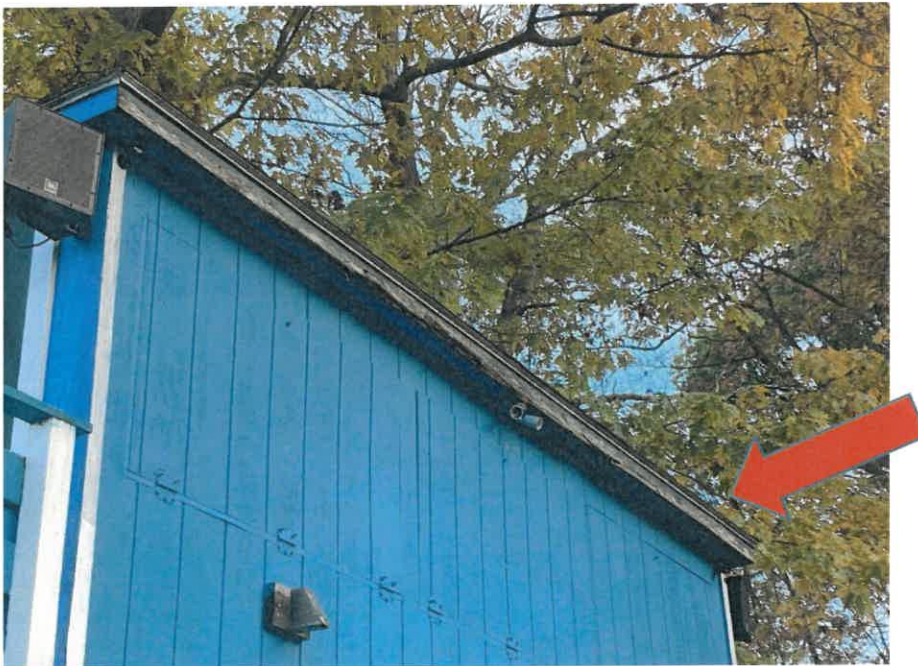
Opposite side of building with more rotting fascia board.

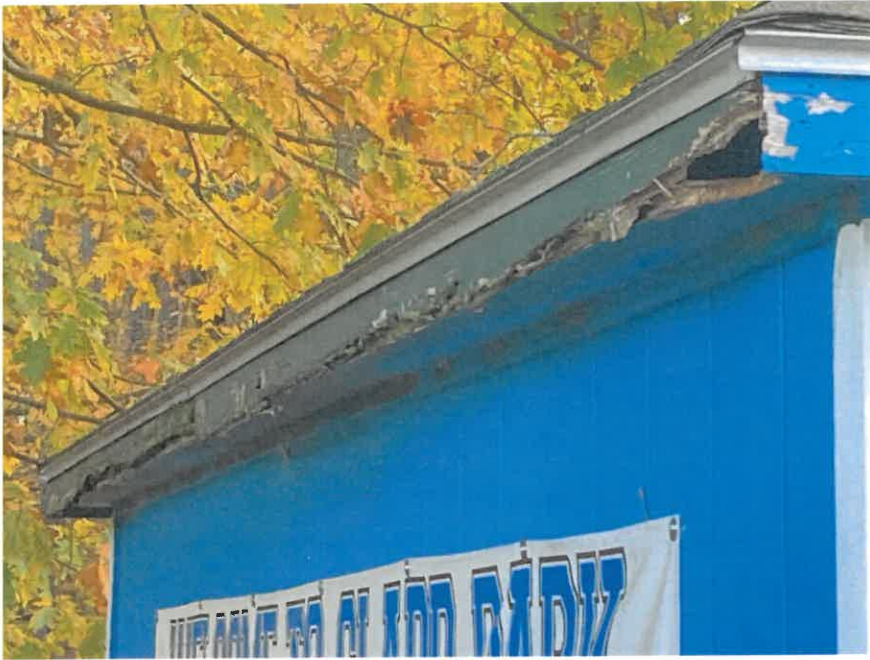
A close-up of the damage to the fascia boards.

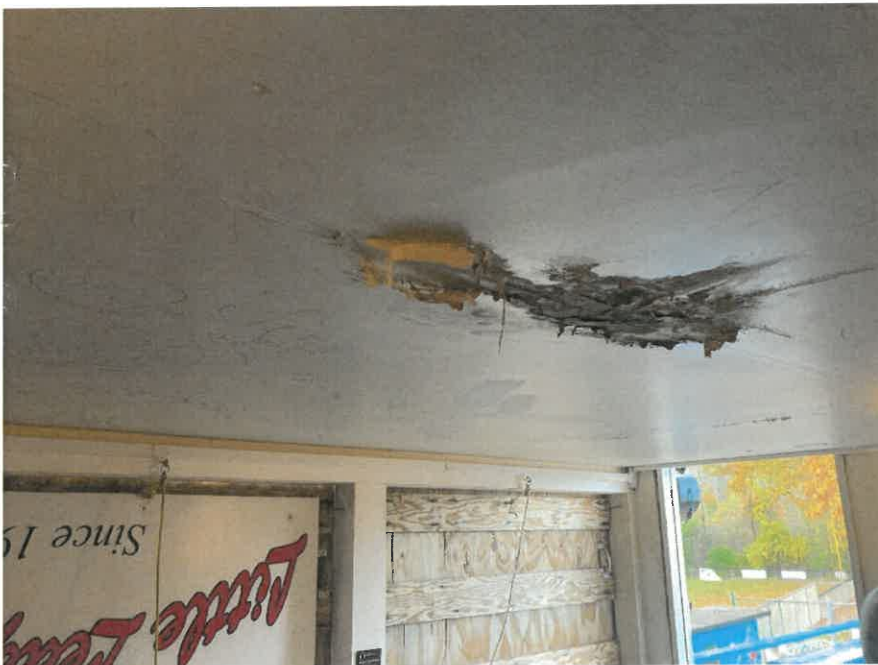
Interior scoreroom ceiling water damage.
